# Failure Analysis of Fractured Poppet from Space Shuttle Orbiter Flow Control Valve

Rick Russell  
Materials and Processes Engineer  
Materials Science Division, NE-L4  
Kennedy Space Center, Florida

# Failure of Space Shuttle Orbiter Flow Control Valve (FCV) Poppet

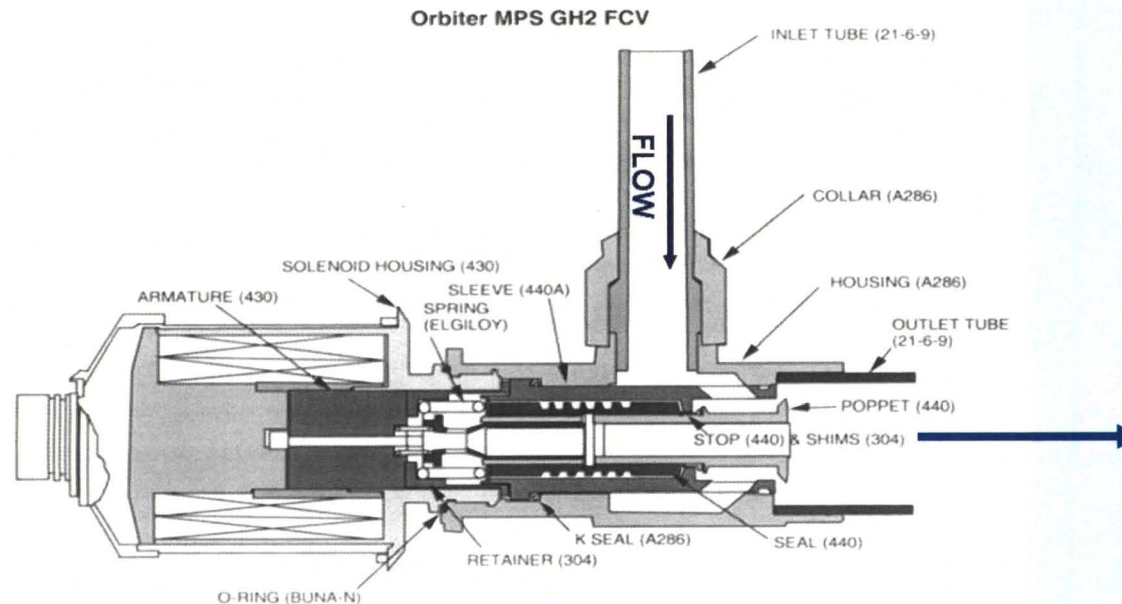
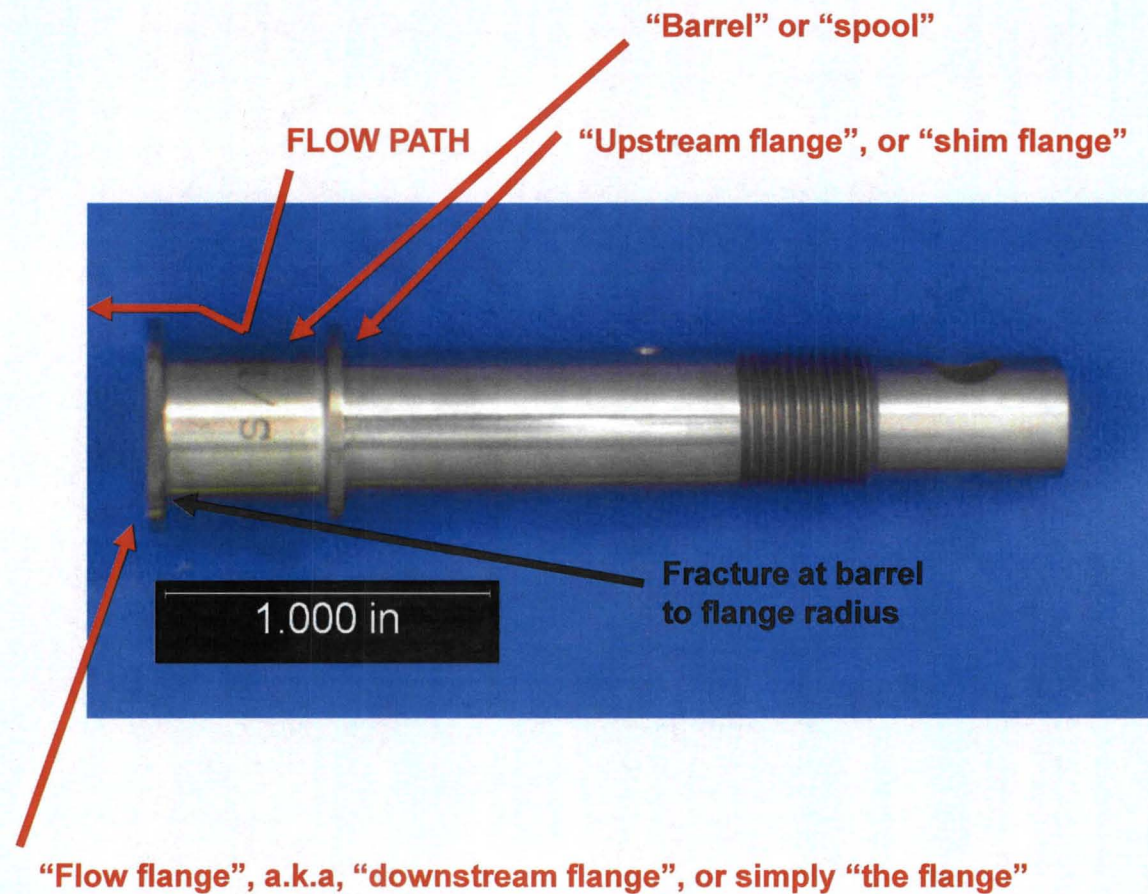
- One FCV per main engine
  - Controls the flow of GH<sub>2</sub> pressurant to the external tank (ET)
  - Two positions: low and high flow
  - Operating pressure is approximately 3400 psig
- Poppet is made from CRES 440A

- Poppet fracture surface exhibited five (5) distinct zones:
  - Zones 1 & 2: Initial “thumbnails”
  - Zone 3’s (2): Circumferential propagation
  - Zone 4 & 5: Propagation through the flange and final fracture
- Fracture initiation occurred at middle of the body-to-flange radius and primarily propagated circumferentially along the radius, then through the flange thickness
  - The general plane of the fracture was  $\sim 45^\circ$  from the flange face

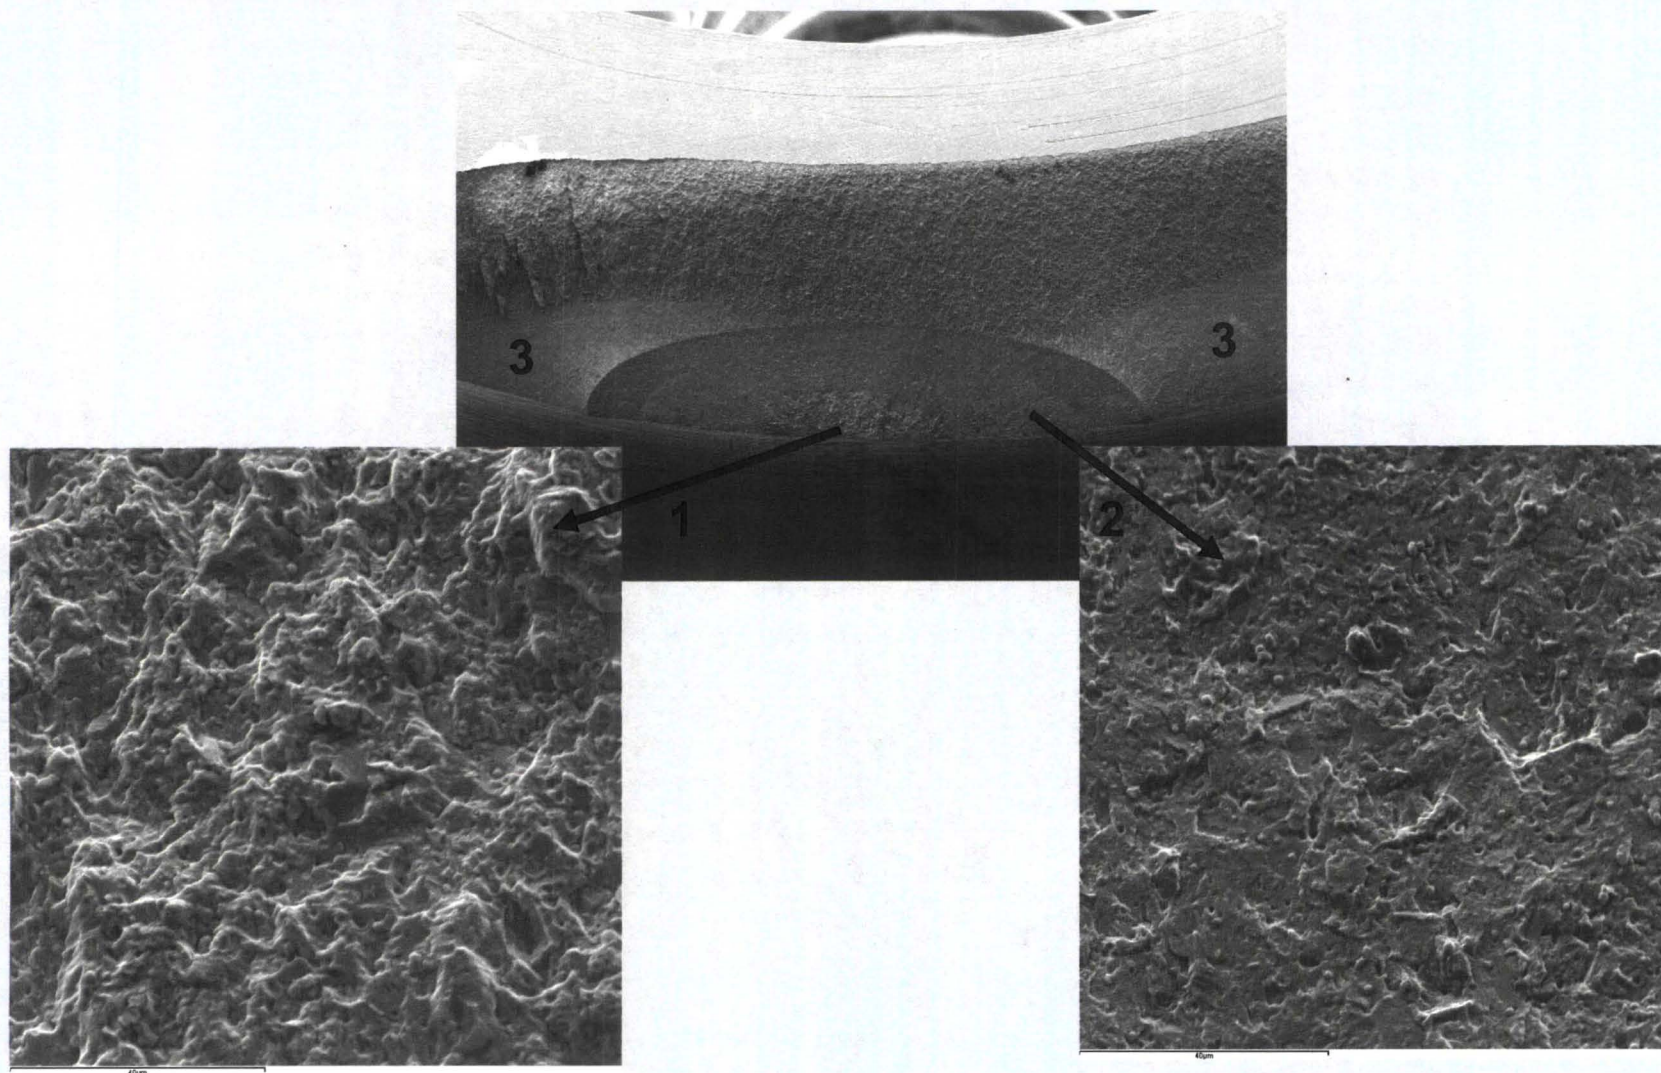
## Zones 1 & 2

- In Zone 2, the fracture propagated on a less torturous path, exhibiting larger “semi-planar” regions, consisted with the smooth, shiny optical appearance. Otherwise, the features were fairly consistent with that of Zone 1.

**A. Large  
blocky carbide  
typical of  
CRES 440**

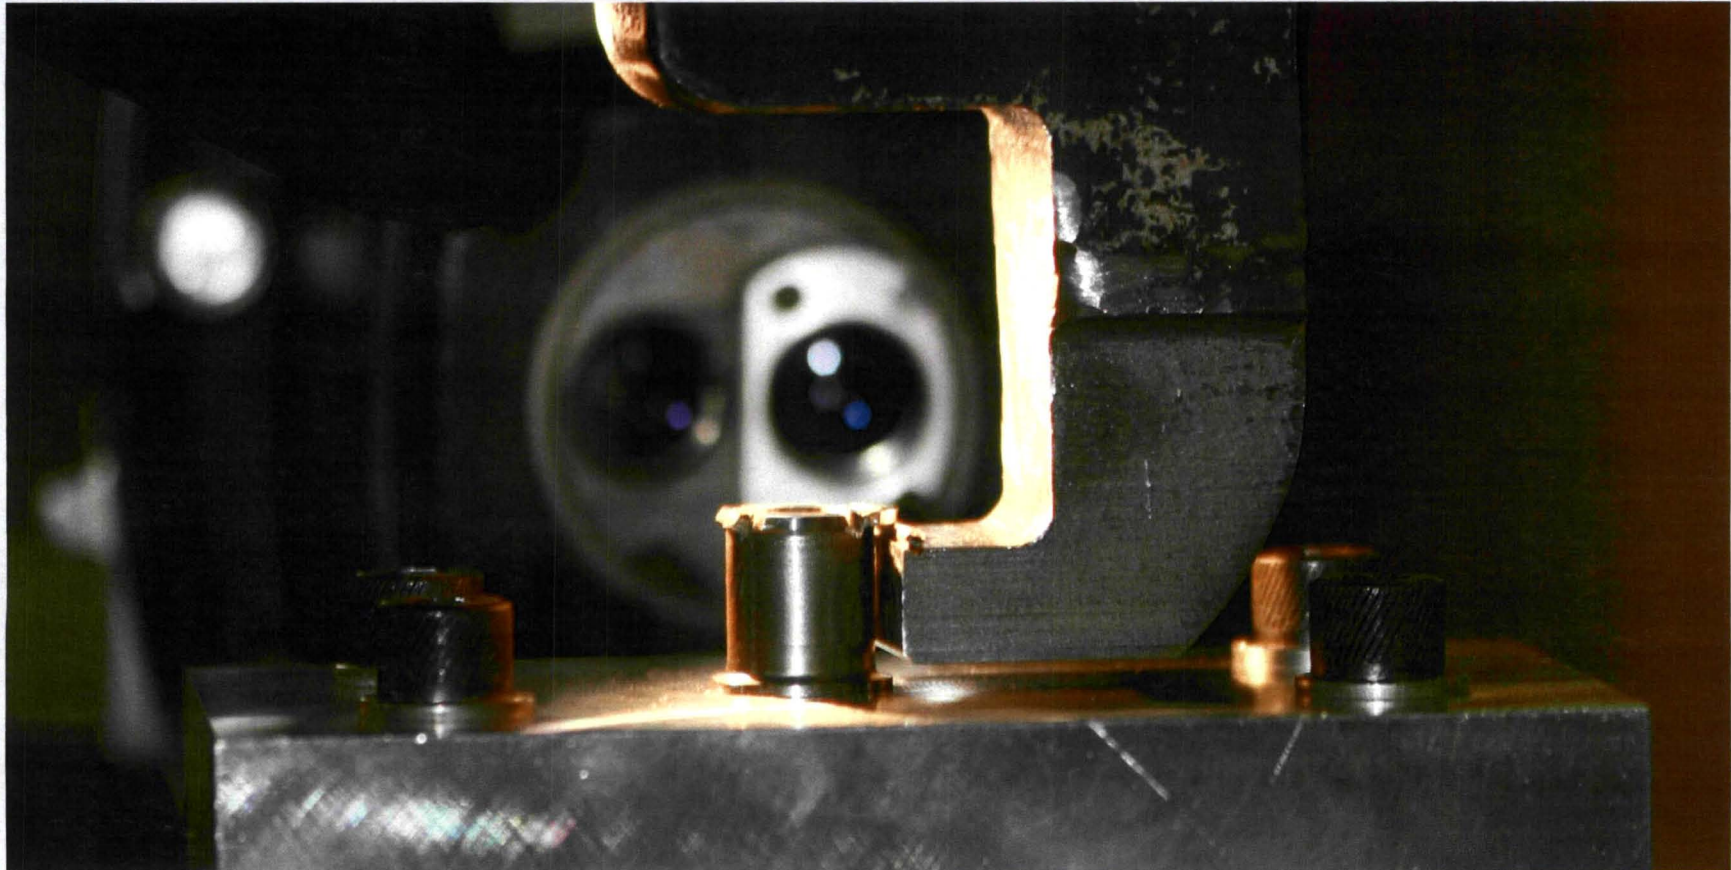
- At the time the failure occurred, there was no known cyclic loading of the poppet to explain the fatigue failure
  - Also unknown was whether the fracture surfaces indicated a high cycle fatigue mechanism consistent with flow-induced vibration or a low cycle mechanism consistent with poppet actuation (translation from low to high flow)
- A test program was conducted using obsolete poppets that were no longer in service
  - To acquire results quickly, the testing was performed with mechanical loading of the flange, as opposed to performing a series of flow tests
  - A hook mechanism was used to pull on the poppet flange, loading the radius in tension
